Order-No.: DD+DIS119.00E

Field Service Bulletin Nr. 9 for ADC Solo Type 5155

Suction cups don't release IP

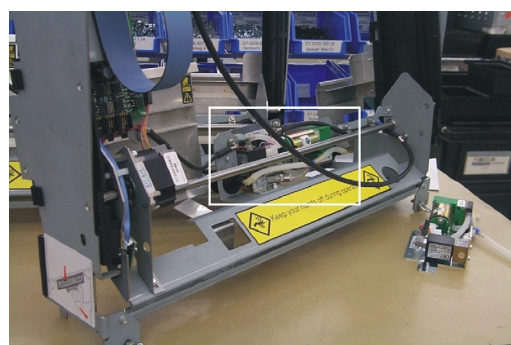
Figure 1

Dust protection of solenoid valve has not been removed.

3. If the dust protection (arrow) is still on the solenoid valve, use a firm solid tool (e.g. screwdriver) to remove the plastic plug from the solenoid valve of the vacuum pump.

The dust protection can be removed permanently. It is not needed during operation.
